CRC Project No. CM-136-09-1B

Engine Durability Study of Mid-Level Ethanol Blends

Status Meeting – June 2011

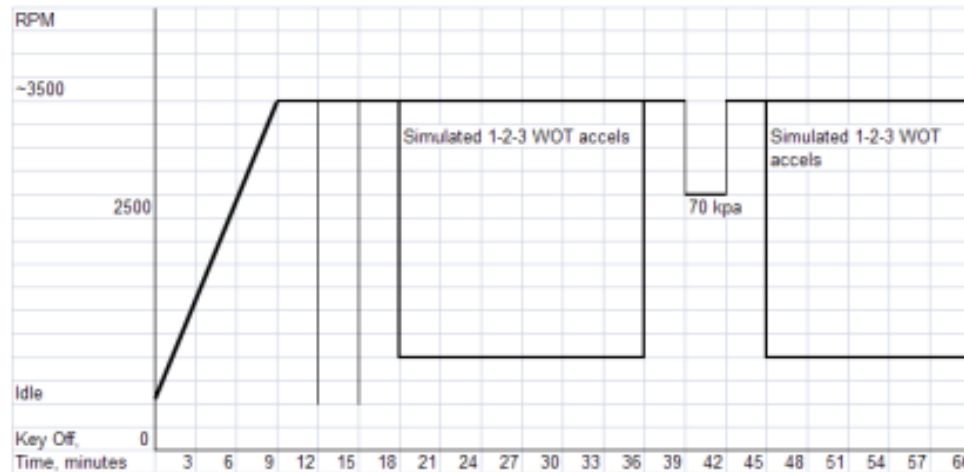
□ The following durability cycle is used to test the engine durability using a mid-level ethanol blend fuel:

□ The test lasts for 500 total cycles and each cycle is 60 minutes in duration.

□ The maximum speed for any engine was 3500 RPM.

- This was chosen because high speed testing can conceal wear issues by increasing oil pullover through PCV and lubricating valve seats.
- This test cycle is substantially less severe than a standard high RPM durability cycle and should ensure that the engine will complete the test.

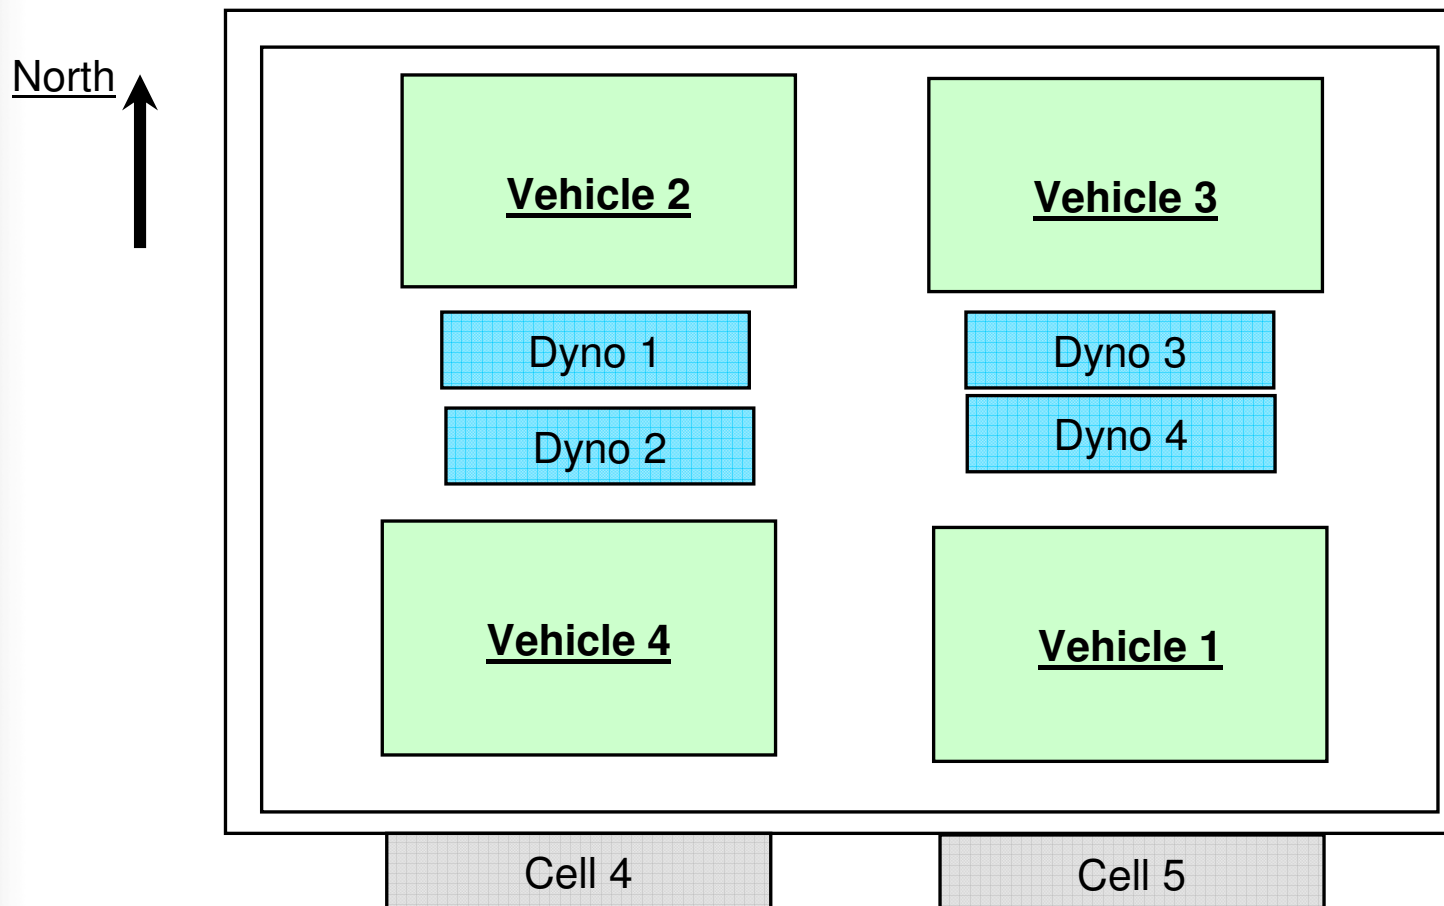
□ The figure below shows an example of the engine combinations in each of the test cells for Rounds 1 & 2. Similar setups are used for all testing.

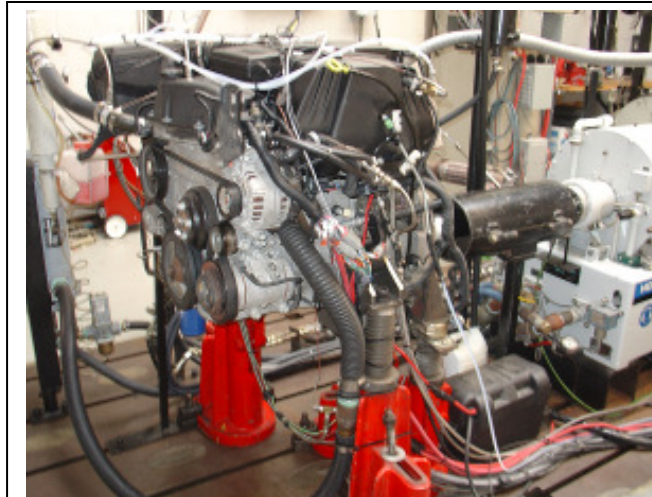
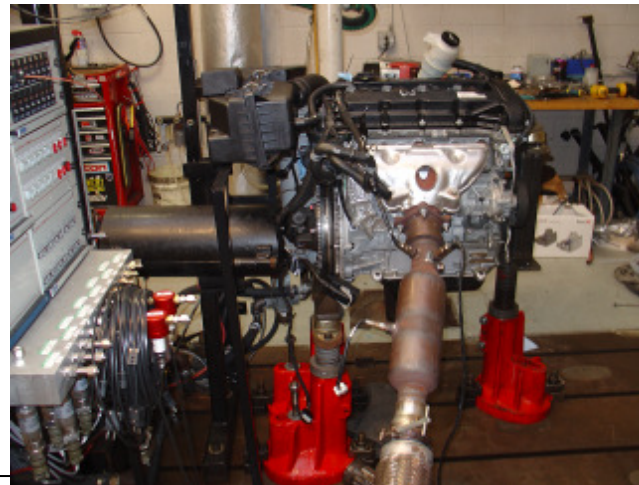
- Test Cell 4
 - Example Engine Setup: Round 1 & 2

Vehicle 2

Dyno

Vehicle 4

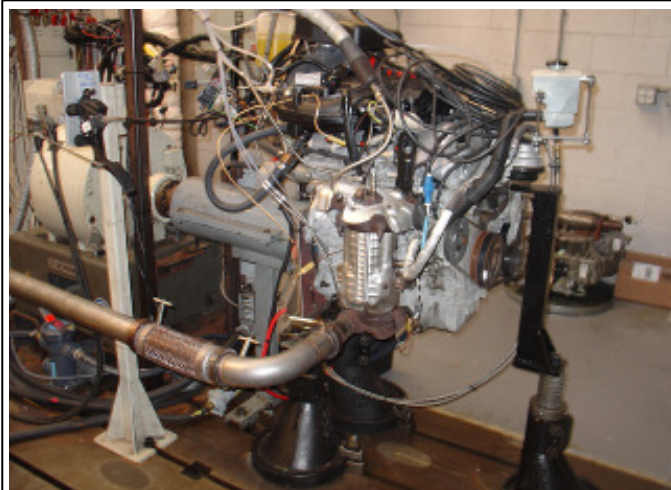
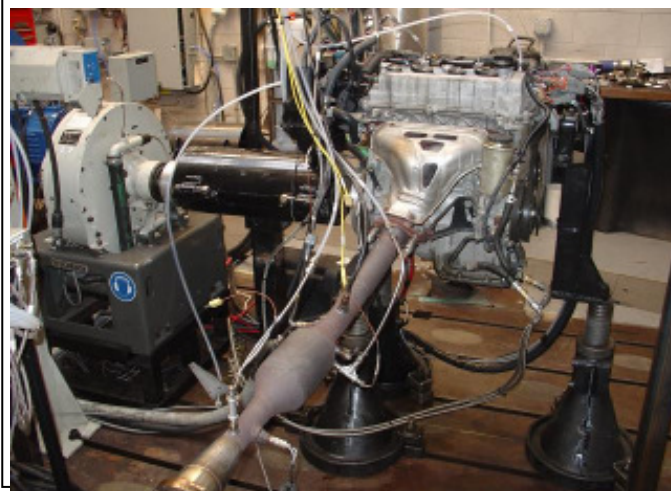
- Test Cell 5
 - Example Engine Setup: Round 1 & 2

Vehicle 3

Dyno

Vehicle 1

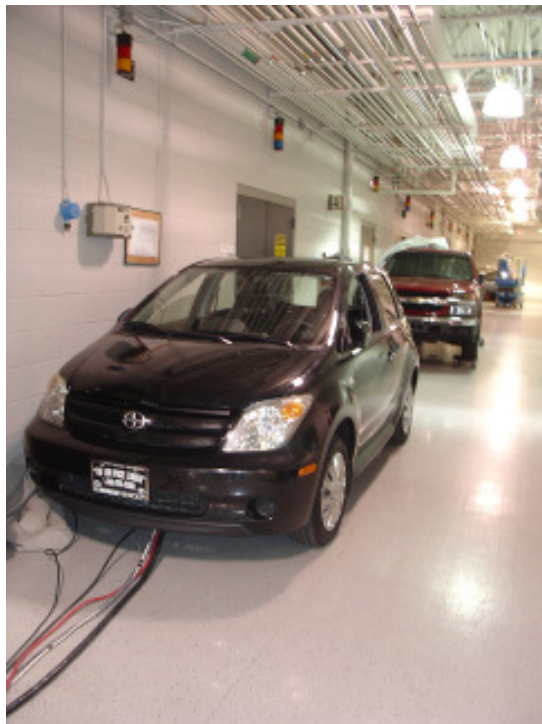
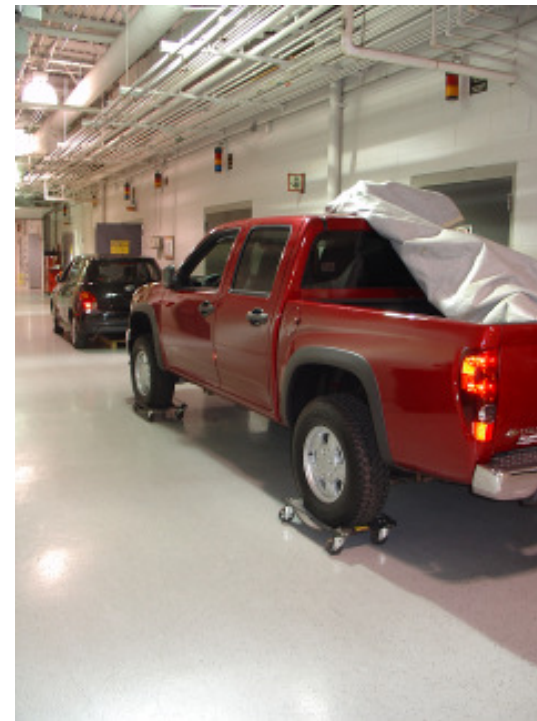
□ The test vehicles require an “umbilical cord setup” for this testing. The vehicle shells are located outside the test cell and wire extensions are made to connect the engine harness inside the test cell to the vehicle harness outside the test cell.
